Clues to Causes of Fatal Florida Tower Crane Accident Point to Platform Cable

July 29, 2024

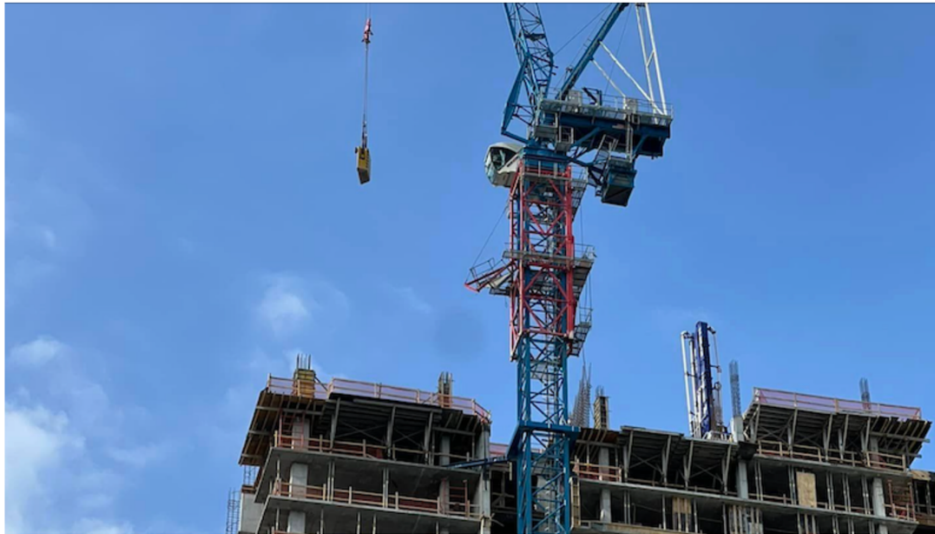
Work platform on red climbing unit, tilted and supported by a single cable near the center of the photograph, is likely to be a key focus in the Fort Lauderdale project accident fatality probe.

The video shows the upper portions of the building, the blue tower crane mast, the red climbing unit and the work platform that hinges out from it. The platform's outer edge should be tied to the climbing unit by cables at the edge corners, but in this case that outer edge seemed to be tied to the climbing unit only from a single cable.

A police report also suggests that the work platform cable may be part of the failure sequence. Officer Jaclyn Smith, who entered the building shortly after the accident, observed that one climbing unit work platform cable was in place while another was “loose and frayed” and unattached. She also observed that “loose wires were attached” to the end of the climbing unit work platform where the loose and frayed cable had apparently failed or detached.
